Tel-Aviv. September 08, 2009

Piezo DC sirens problems for June until August 2009 shipments

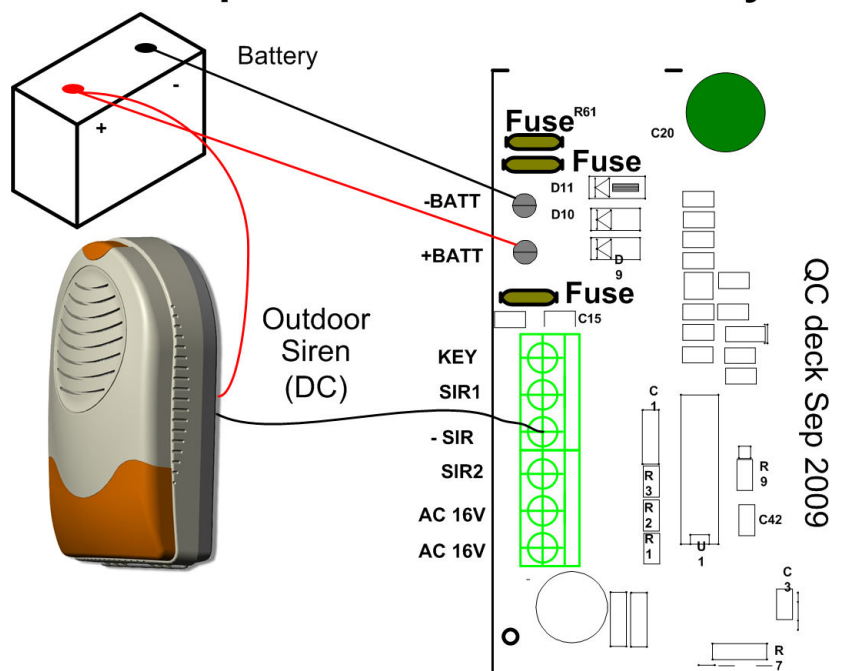
How to power sirens from battery

To prevent problem caused by DC sirens ,connect the Positive Siren/s lead/s directly to + battery

To bypass the problem: Power off the panel, remove the +SIR wire terminal in the panel, wire the positive siren/s lead/s directly to the battery positive terminal.

Keep the negative siren lead wired to -SIR at panel. Please do so for both internal and external sirens.
